Data Analysis and Interpretation

Painkalac Creek Estuary 2007-2013

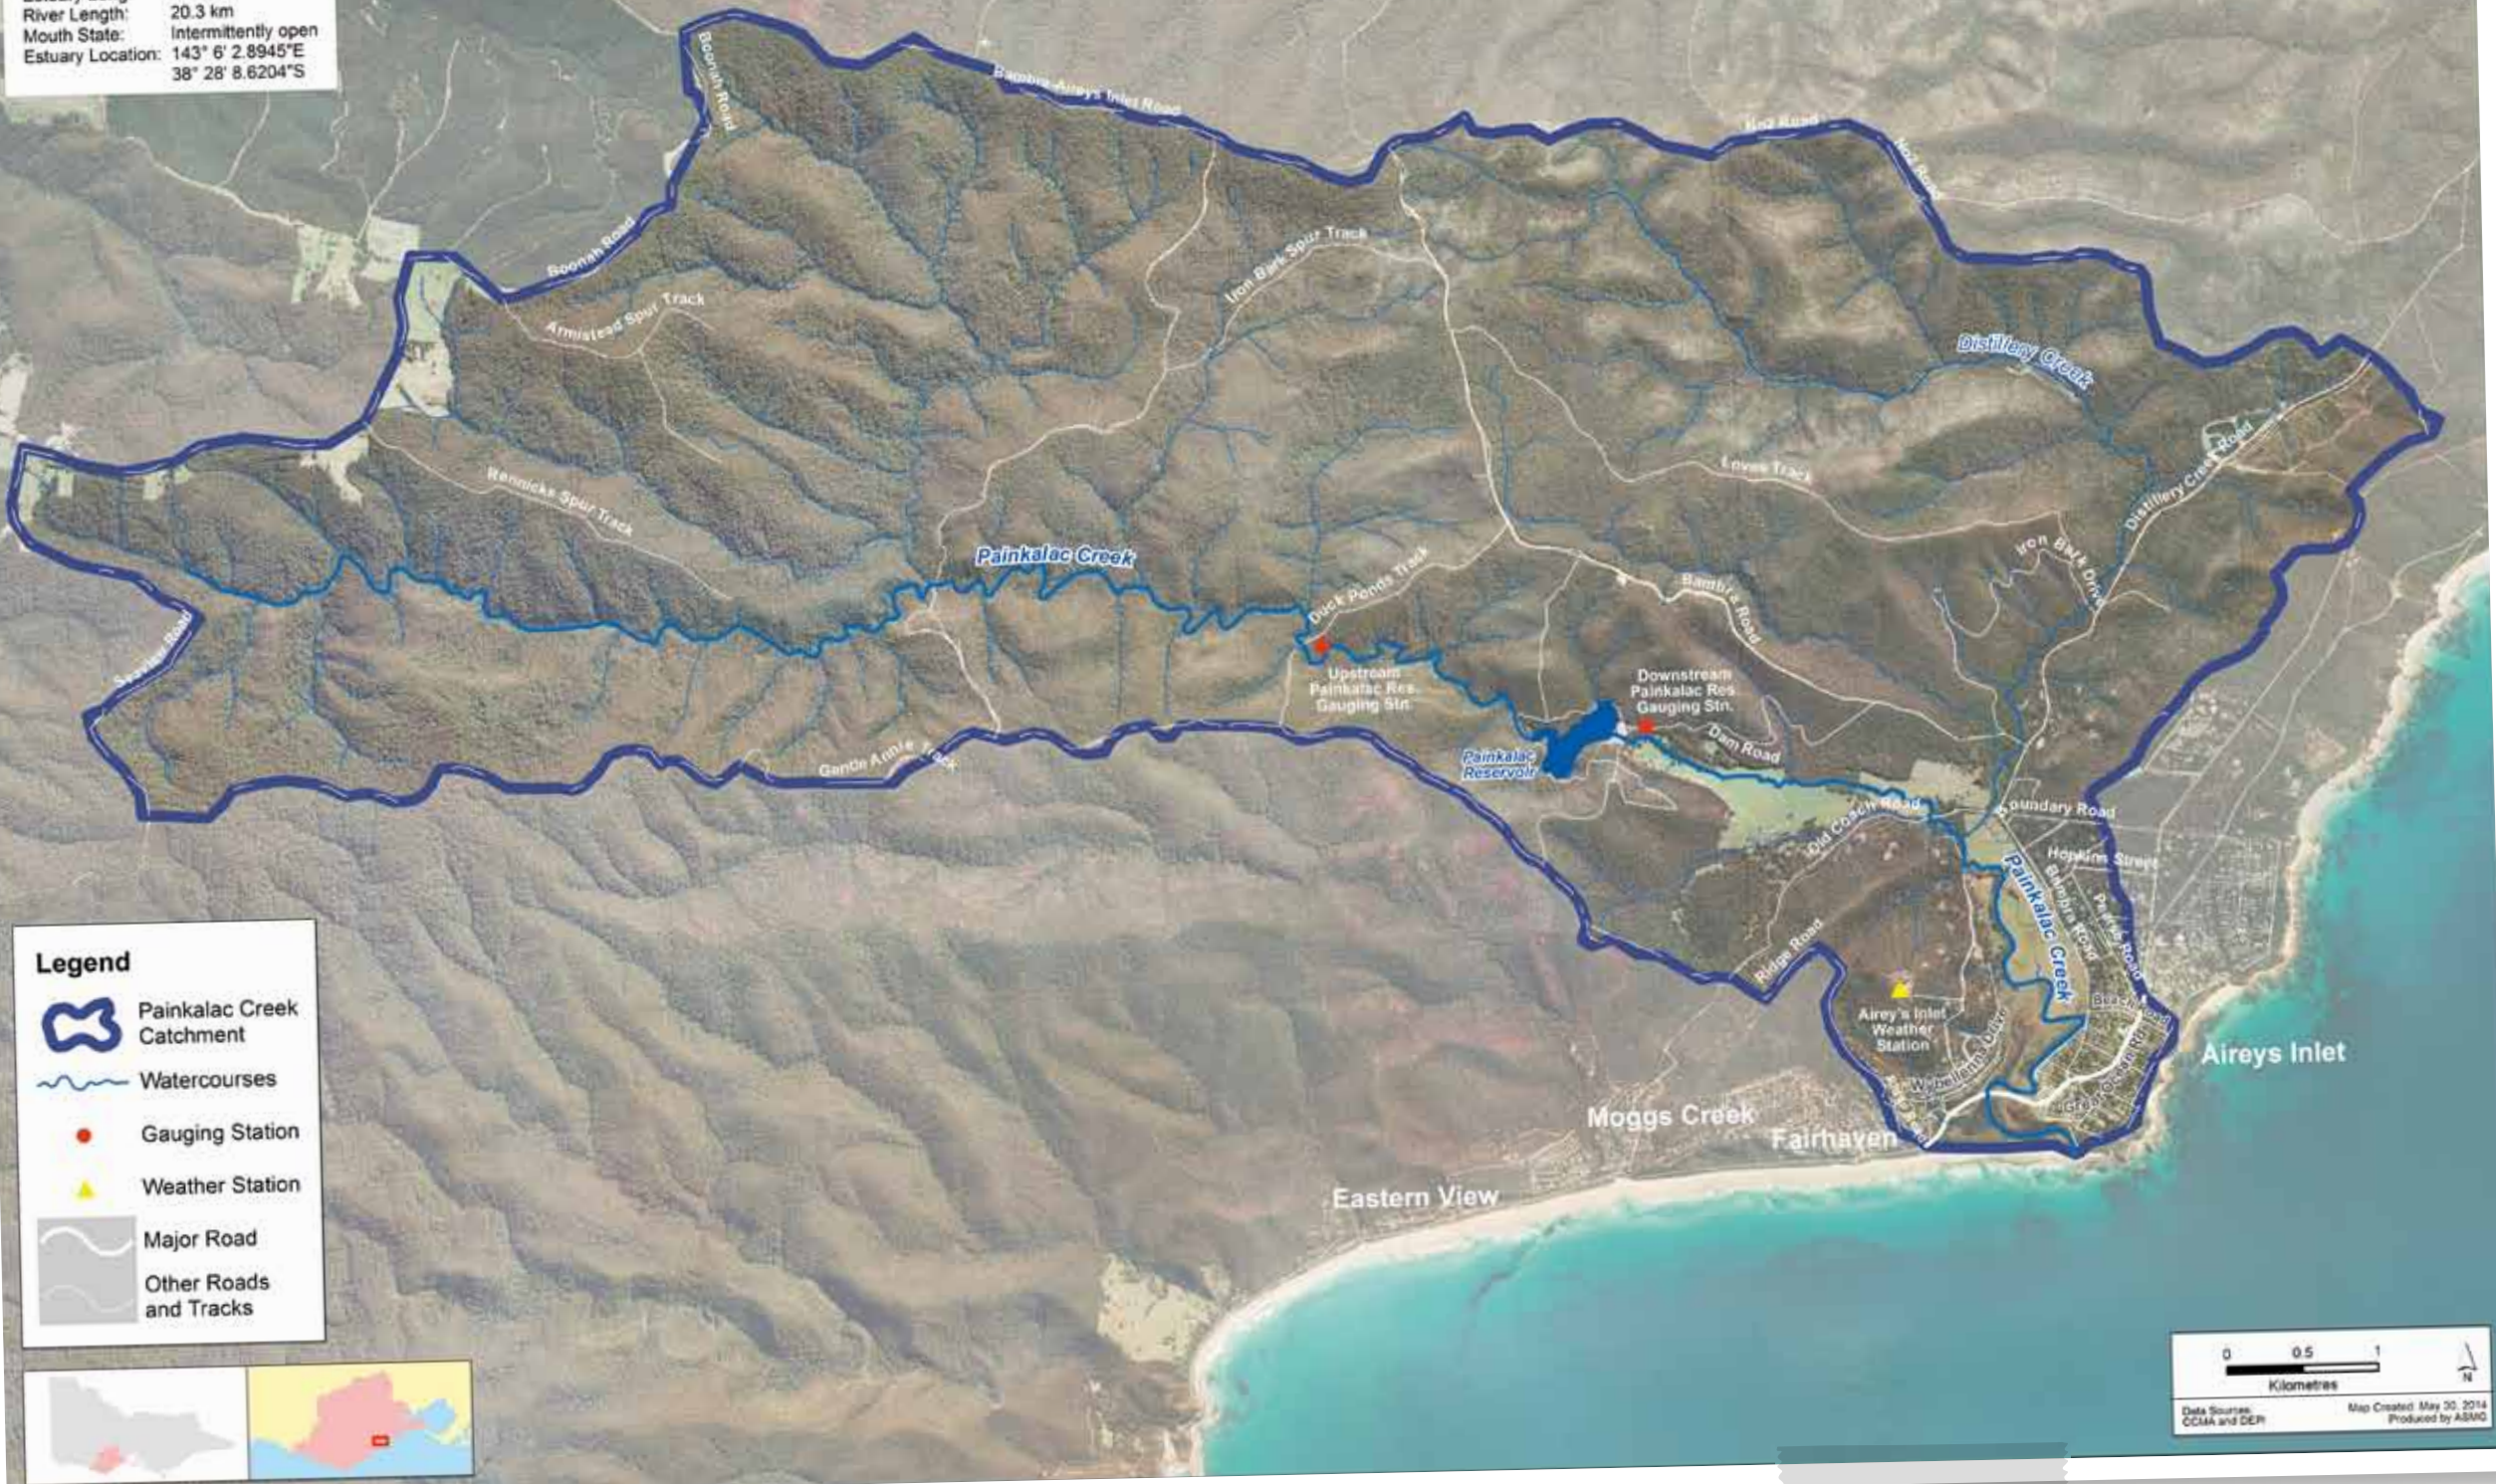
Figure 2. Painkalac Creek catchment with the locations of the Painkalac Reservoir, Aireys Inlet weather station and gauging stations upstream and downstream of reservoir.

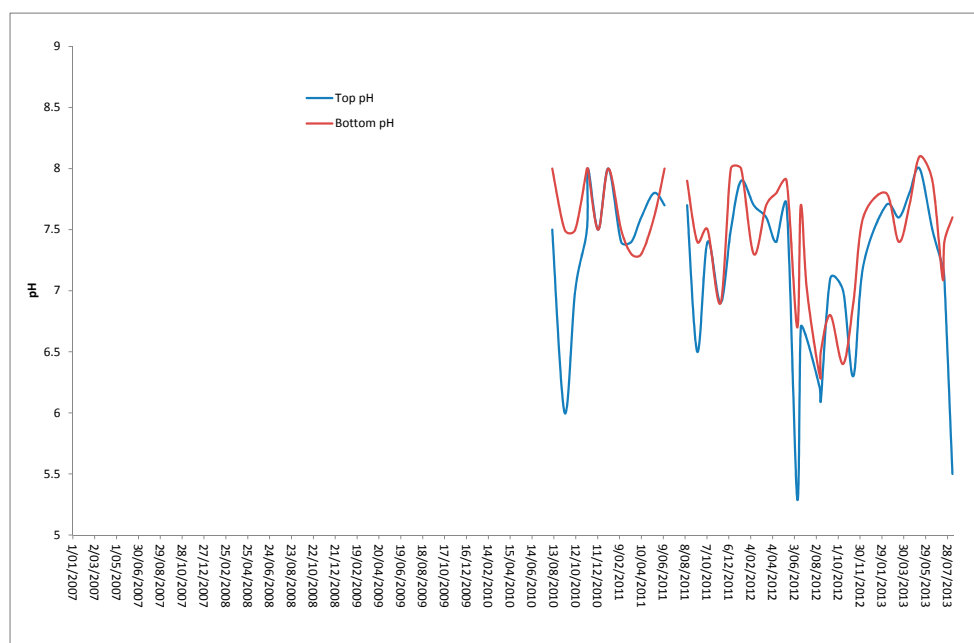
Figure 20. The pH at EstuaryWatch site P2 from 2007-2013.

pH measurements have only been recorded from late 2010. However, they do show some concerning factors. The pH in the top water on several occasions were 5.5 and 5.3, these values are quite low and should be considered for further investigation, as these levels may cause stress to organisms living in the estuary.

The expected range would be 7-8.5 for a healthy system. The pH of the top waters ranged from 5.3-8, and the bottom waters ranged from 6.2-8. The times of low pH values corresponds with high rainfall and river flow and may be the result of drainage of acid sulphate soil as often occurs in the neighbouring Anglesea River estuary catchment.

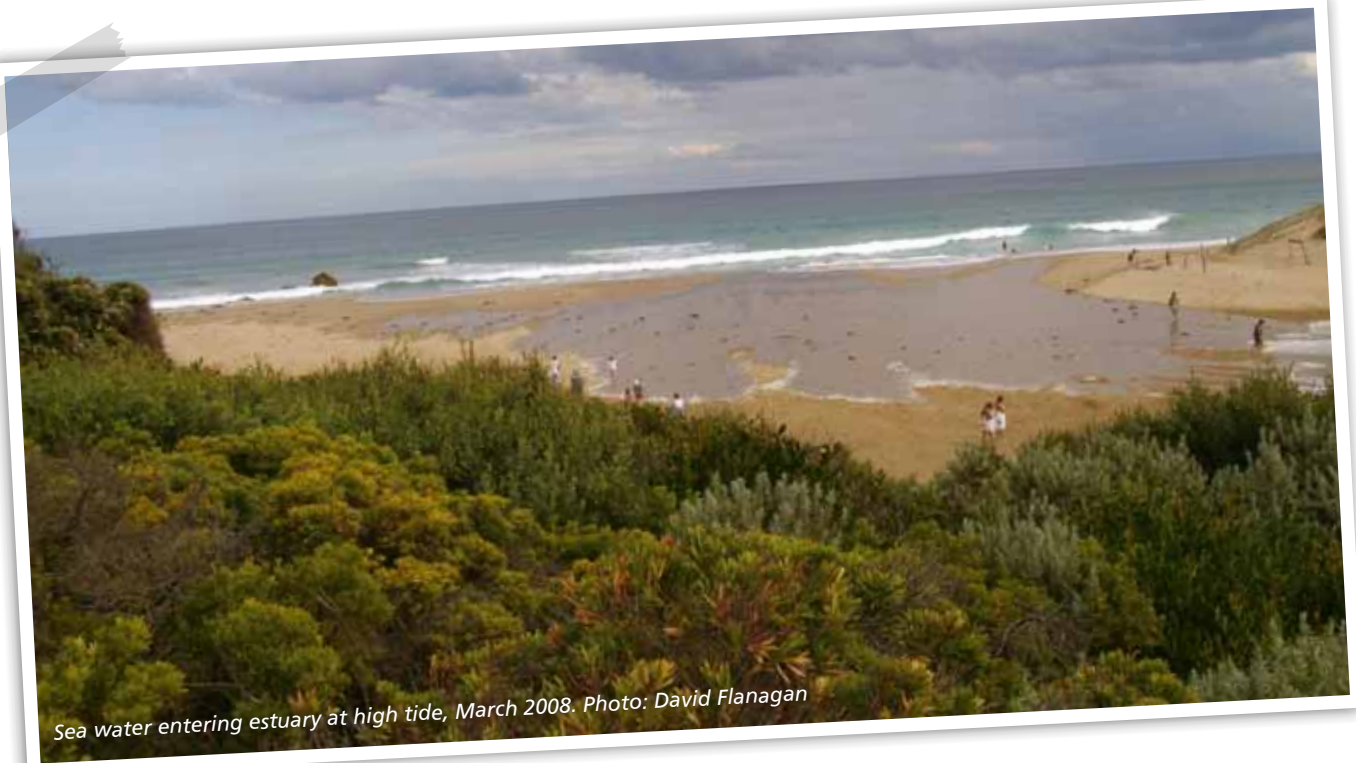
Sea water entering estuary at high tide, March 2008. Photo: David Flanagan

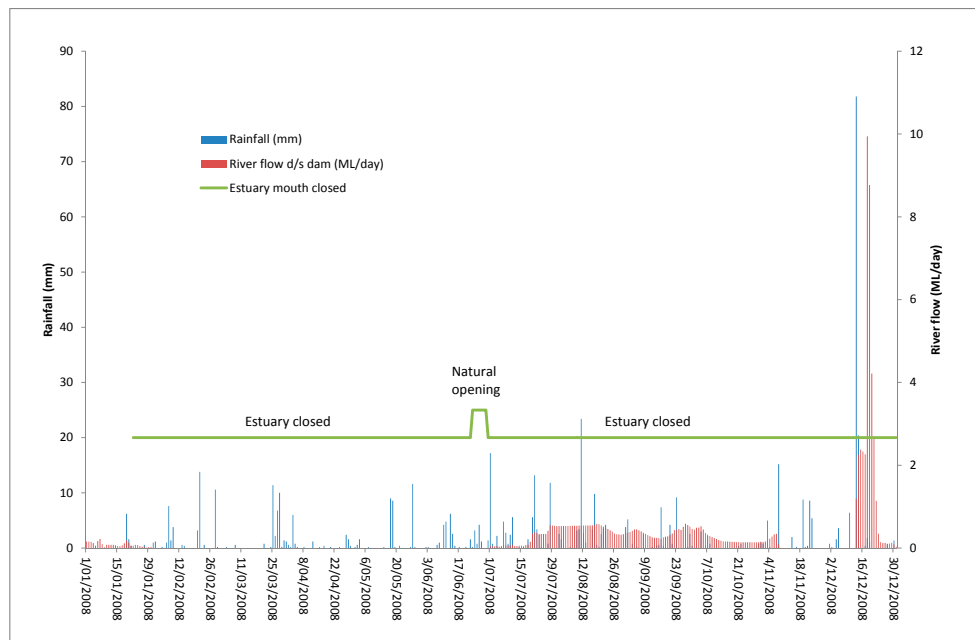
Figure 27. Rainfall, river flow and estuary closures and openings during 2008.

In 2008 the estuary was closed to the sea apart from one potential natural opening in June (Figure 27). This closure continued until October 2009. During the summer-winter period the estuary experienced extremely low water levels, recorded as being below the gauge board, this was not apparent in the depth readings at site P2 (Figure 28). Also during this time sea water was observed entering the estuary at high tide. Rainfall during 2008 was extremely low, as were the river flows, no river flow entered the estuary for the first half of the year. In 2008 the Painkalac Reservoir was at 100% capacity from January 1 to January 8 and December 15 to December 31 (Barwon Water, 2014).

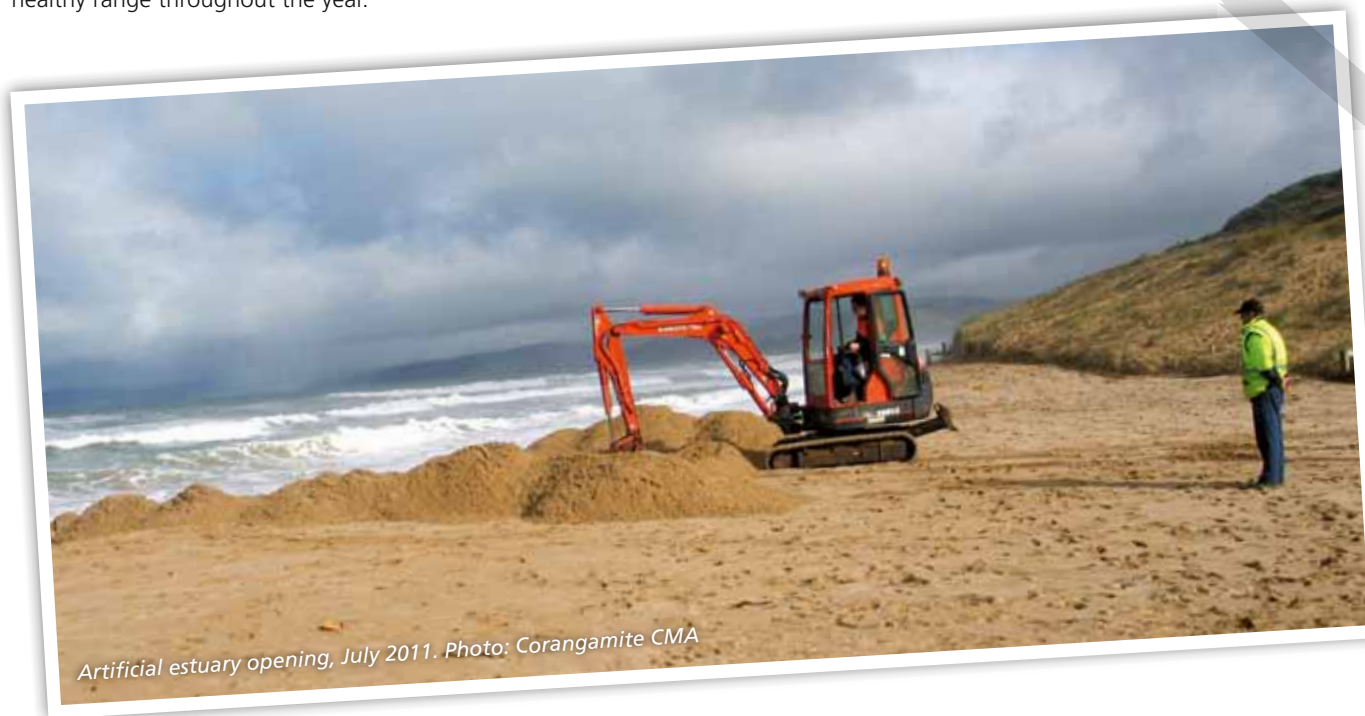
Artificial estuary opening, July 2011. Photo: Corangamite CMA

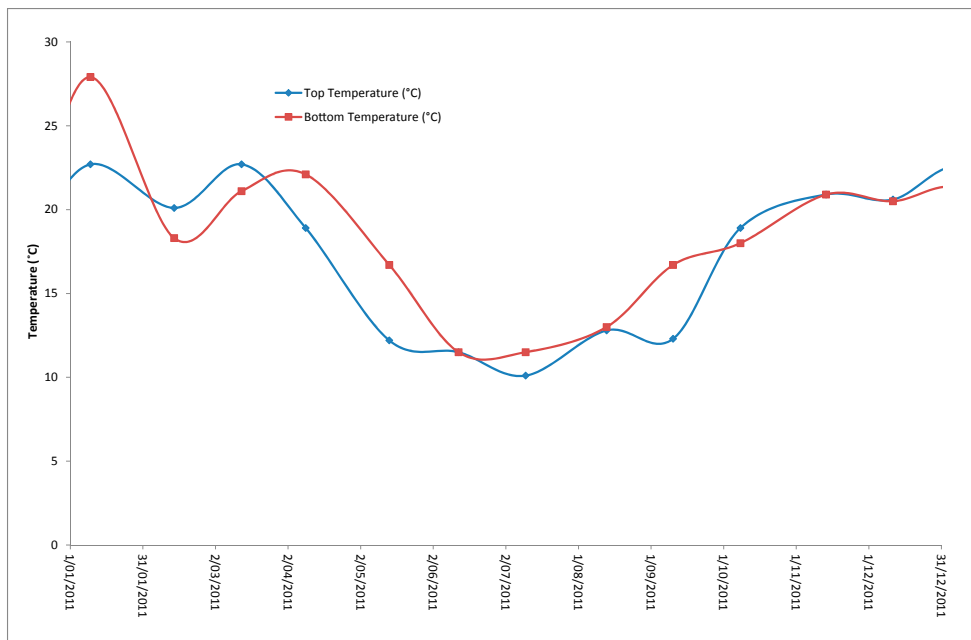
Figure 48. Temperature (top and bottom) at site P2 during 2011.

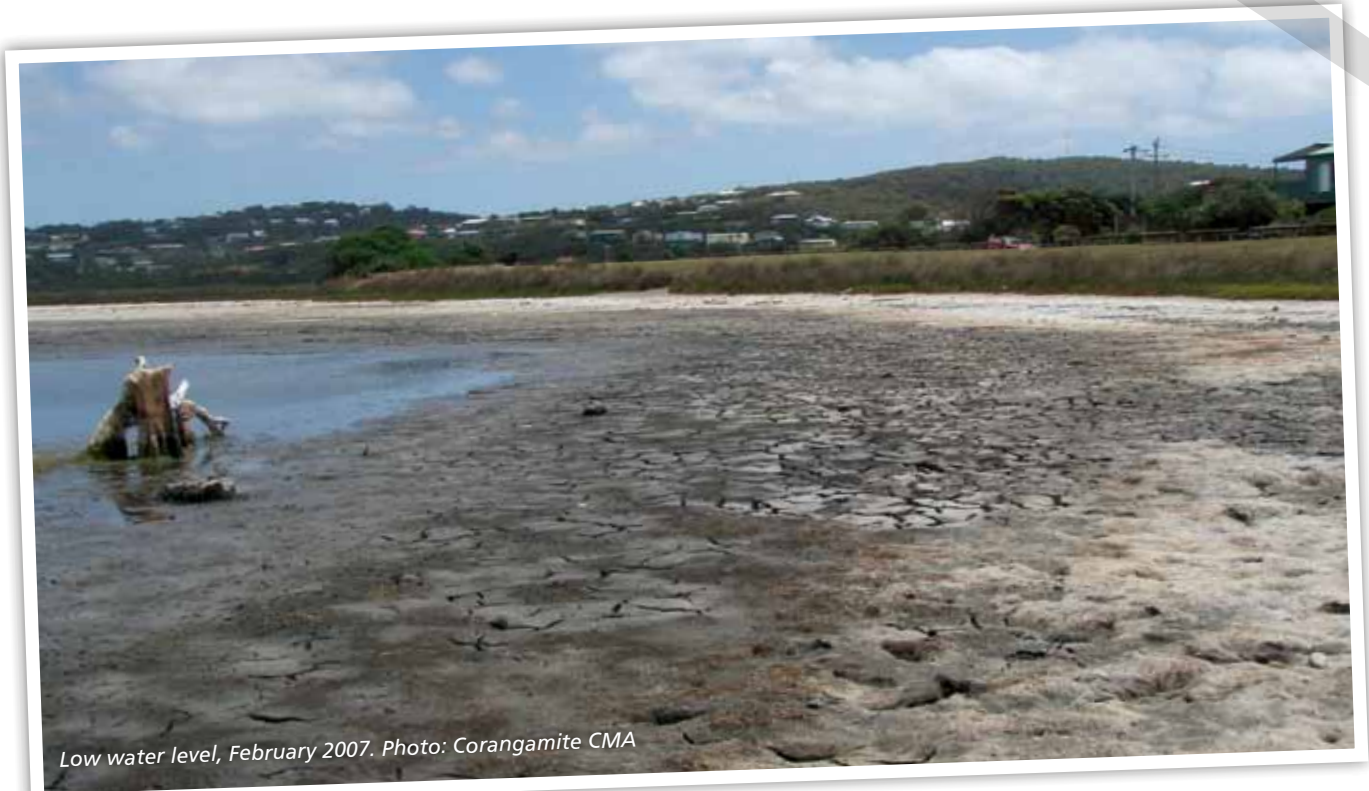
Low water level, February 2007. Photo: Corangamite CMA
