PAINKALAC CREEK ESTUARY

An interpreted summary of data

Extract from Painkalac Creek Estuary Data Analysis and Interpretation 2007-2013

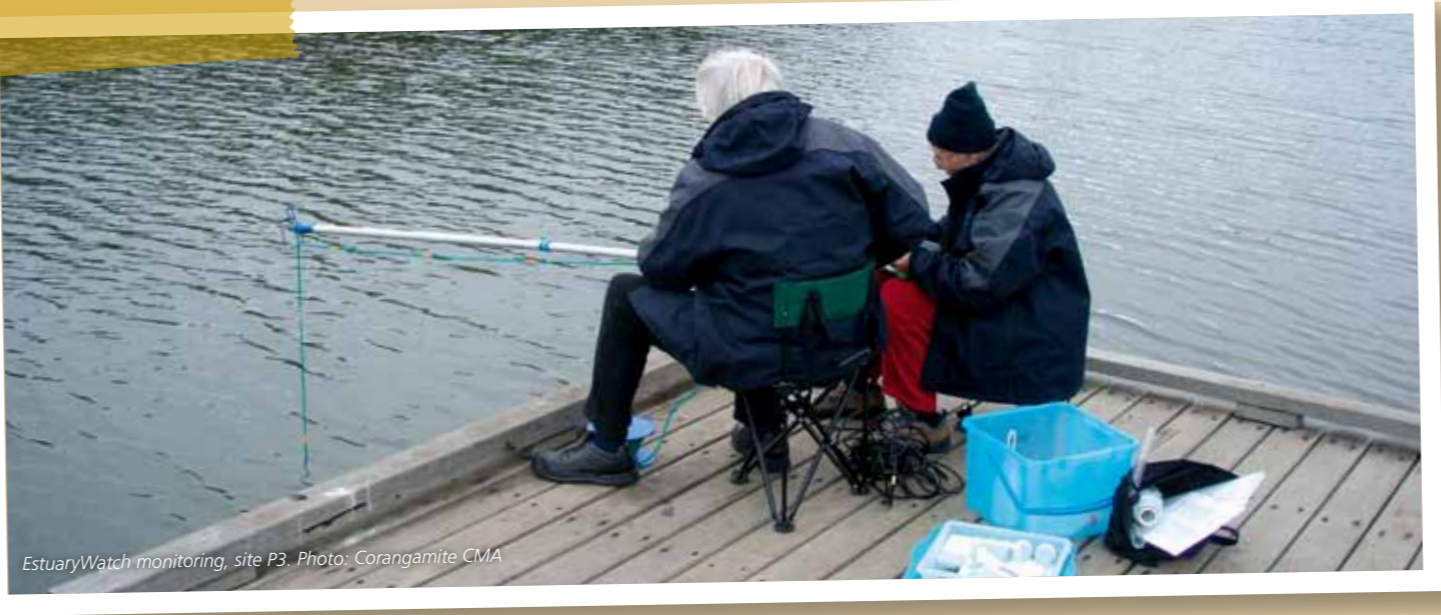
EstuaryWatch monitoring, site P3. Photo: Corangamite CMA

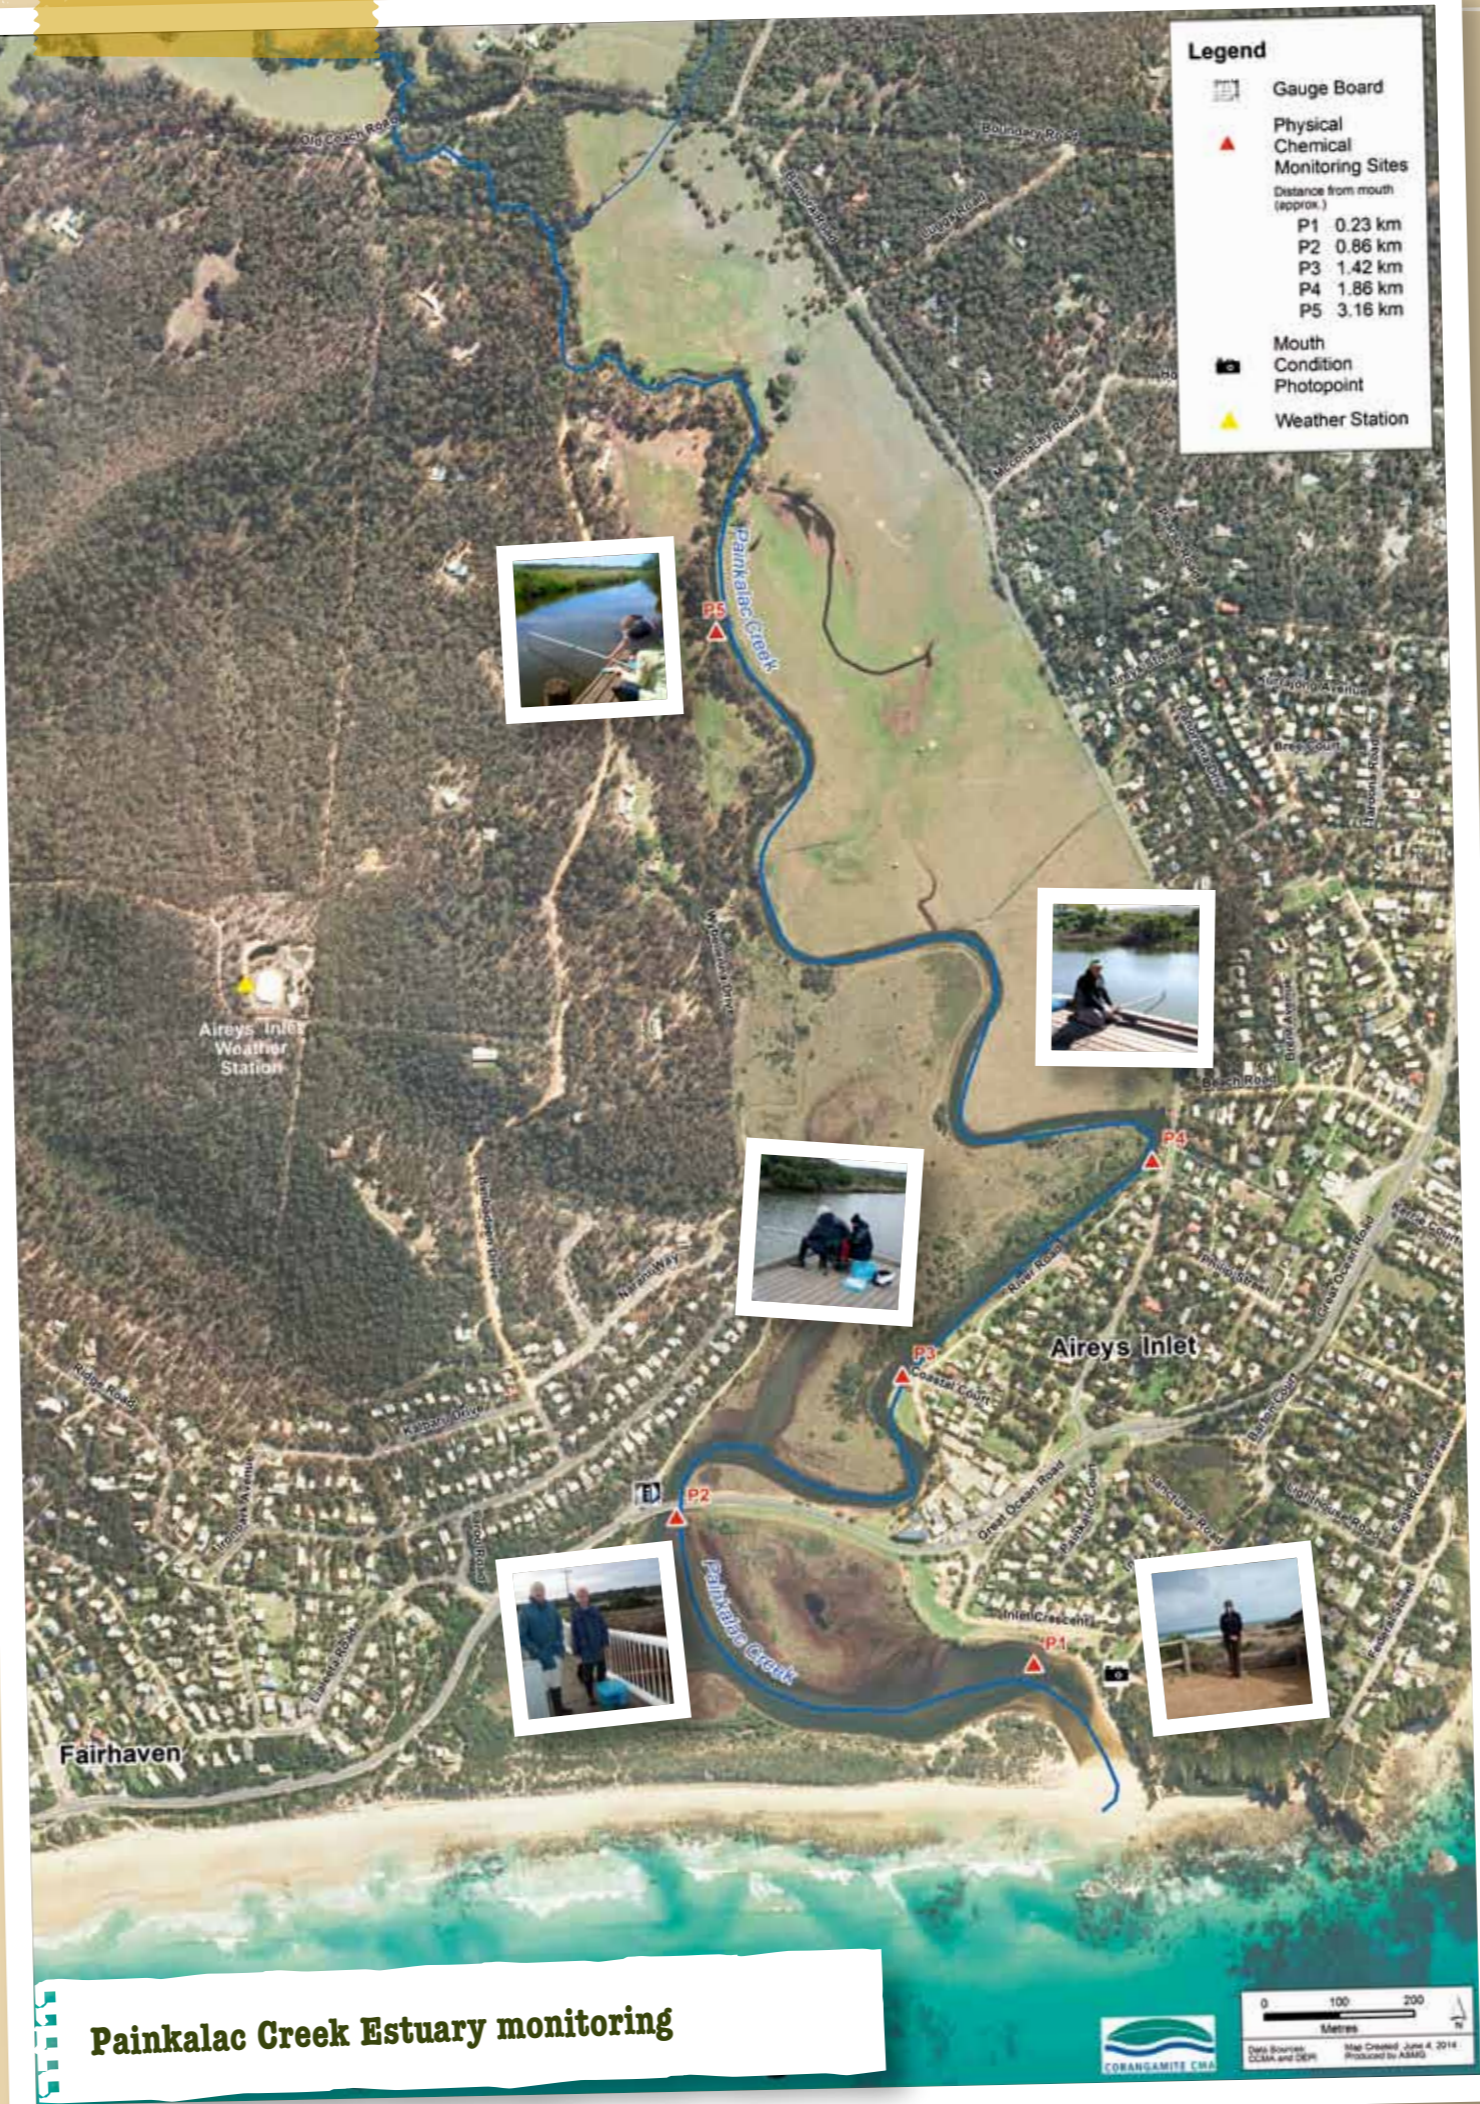
Stratification process

Characteristics of a stratified estuary include a distinct increase in salinity with depth, where less dense freshwater overlays denser seawater and little or no mixing between the layers. This boundary layer, or halocline, marks salinity increase/decrease. The volume of seawater entering an estuary depends on several factors, including river flow, entrance channel width and depth, tidal range and storm surge. Dense seawater sinks below less dense freshwater and slowly moves to the bottom of the estuary. As the tide recedes, the freshwater flows over the seawater trapping it in the deeper parts of the estuary. Some mixing may occur creating a brackish layer. The returning high tide begins the process again and more seawater enters the estuary. In the Painkalac Creek Estuary the stratification process is commonly observed when rainfall and river flow increase. The influent freshwater enters the estuary forming a layer of less dense freshwater overlaying denser brackish/salt water. The effect of this results in the formation of a halocline as little as 0.5m below the surface restricting the mixing within the water column, isolating the denser salt water from the atmosphere and reducing the diffusion of oxygen into the waters below the halocline.
